# Lower Animas River Watershed Based Plan

Accepted by EPA August 9, 2016  
Updated December 30, 2021

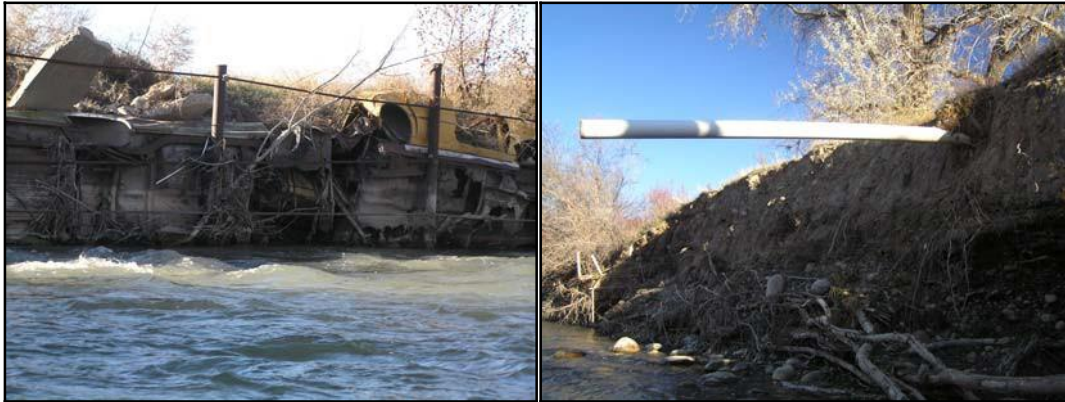
**Figure 17. Picture of inappropriate bank stabilization (L) and actively eroding bank (R)**

Results of this mapping showed that at least 8% of the 38.7 mile length of the study reach is in poor condition, with over 1 mile of actively incising channel and over 2 miles of rip-rapped bank with materials such as boulders, automobiles, scrap concrete, gabions, scrap metal, and other refuse (BUGS 2008).
